Journal of Food Science and Agricultural Technology

# Status of Good Manufacturing Practices (GMP) of Small and Medium – Scale 20-Liter Bottled Water Plants in Cambodia: Case Studies in 4 Provinces

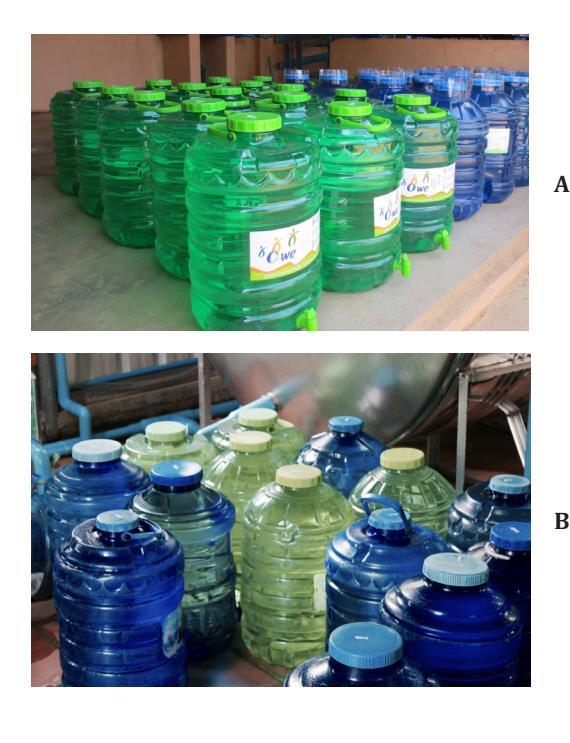
Figure 1: The design of 20-L containers

Table 3 gives the GMP scores for each audited plant for all 9 aspects that were rated by the expert. Most plants lacked information on raw water quality, which consequently affected the design of their treatment systems. However, this point did not affect the score, since the plants implemented systems that could cover all types of raw water quality (overuse of the treating equipment). Most production plants failed in the topic of cleaning and disinfecting the 20-L containers; none of them had a proper system. Most plants used a pressure pump to clean the used tanks, but they did not use any cleaning agents or disinfectants. This practice was quite inconsistent and unpredictable due to human error. Most plants also did not have a hygienic packing area or storage area for the 20-L containers, which could potentially cause contamination in the treated water.
